### Inspection Report

#### Minerals Regulatory Program

<b>Mine Name:</b> Flower Patch	<b>Permit Number:</b> S/039/0019
<b>Operator Name:</b> Bown Stone Products Inc.	<b>Inspection Date:</b> July 3, 2013
<b>Inspector(s):</b> Peter Brinton	<b>Time:</b> 9:45am – 10:45am
<b>Other Participants:</b> Matt Bown, Bown Stone Products Inc.	<b>Mine Status:</b> Reclaimed

**Purpose of Inspection:** Evaluate site reclamation for bond release and to close the Division directive

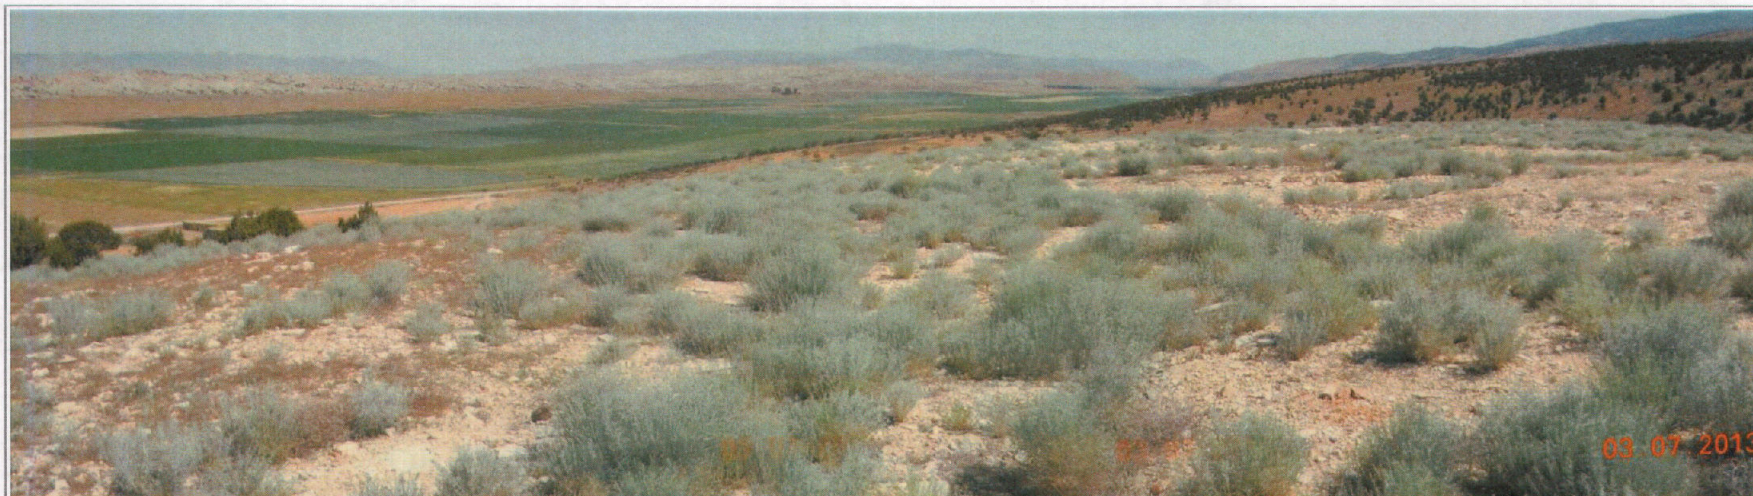
Example of revegetated areas recommended for release. The primary species is rabbitbrush. Old weed skeletons are also visible. Stitched photo.

It is recommended that the earthwork part of the bond be released. Considering growth on graded areas, and the nature of vegetation on areas not disturbed by mining, it is recommended that all but 1.6 acres be fully released and that revegetation bond retained. Periodic inspection and weed control (as needed) are recommended.

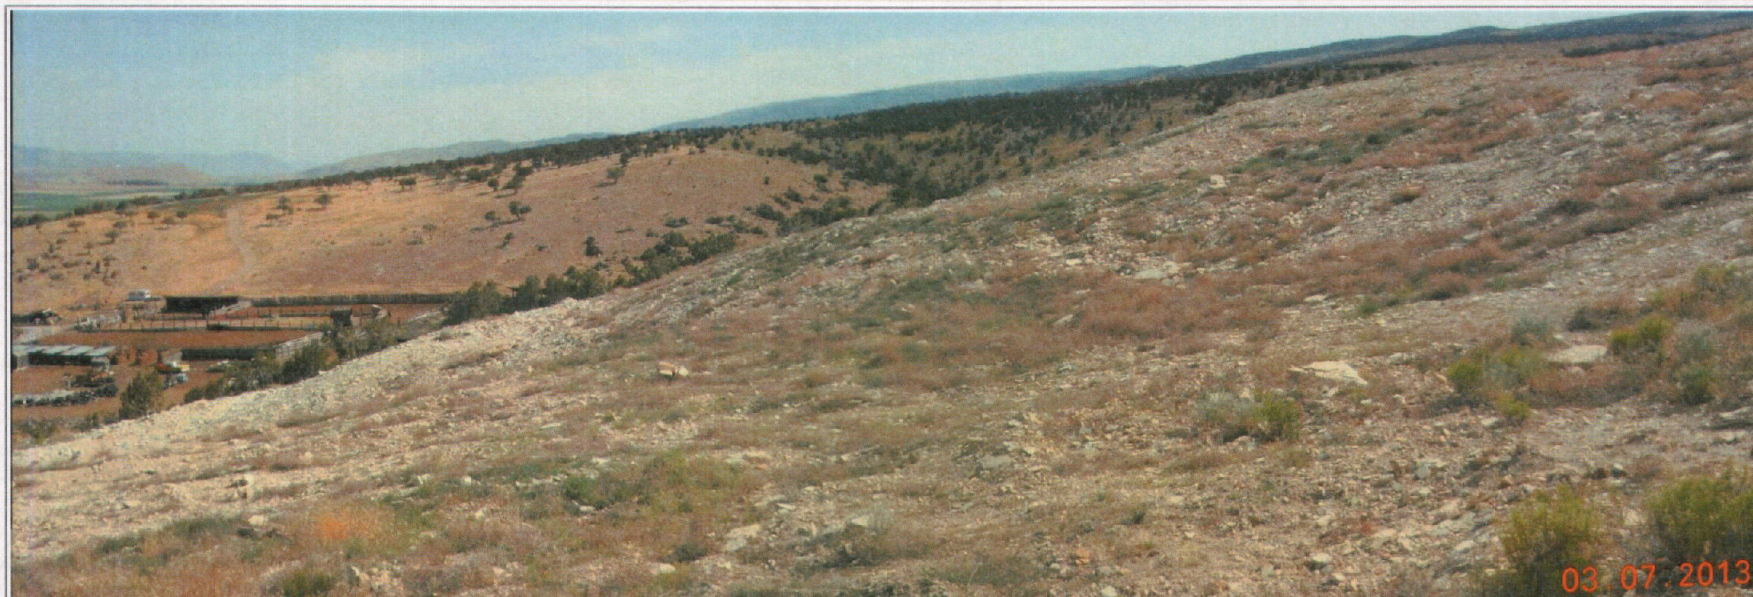
Significant growth has occurred since the last inspection. Except for 1.6 acres measured by GPS from the most recently graded area (lower on the hill), vegetation is acceptable to release. Rabbitbrush has filled in areas once dominated by Russian thistle. A few weedy grasses were also found. Unmined adjacent areas are composed of cheatgrass, juniper trees, and some snakeweed, among other species. The area recommended for release will support a comparable post-mining land use. Lynn Kunzler, who formerly inspected this site, confirmed these conclusions after looking at photographs.

Stitched photos of areas not recommended for release (looking generally north-northeast). Most vegetation is either old or new Russian thistle. Stitched photo.

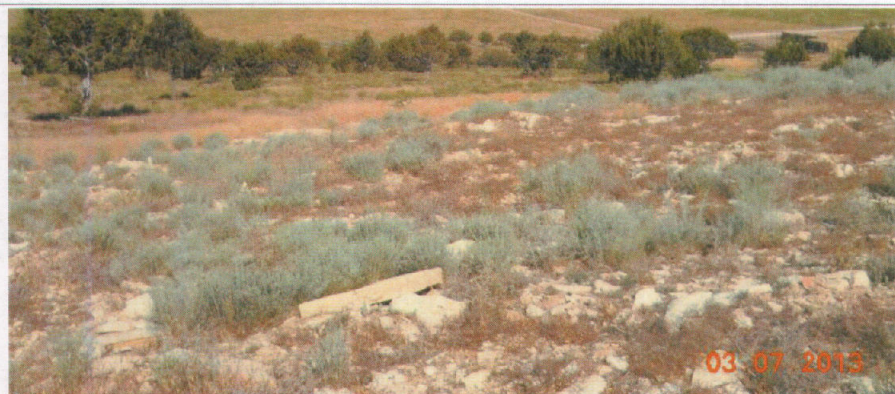
Reclaimed (foreground with Russian thistle skeletons) and unmined (trees) areas.

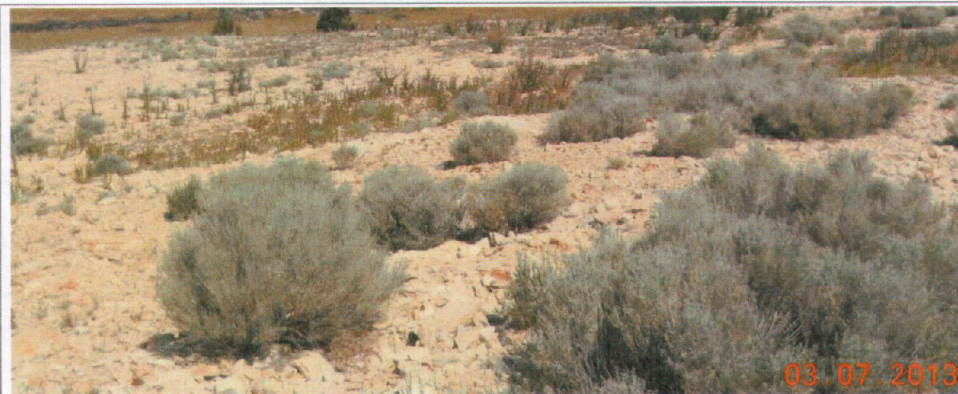
Lynn identified what may be an isolated knapweed sample taken from the 1.6 acre area not recommended for release (which also had a few other unidentified, non-noxious weeds. Also, the nearby Creamtime quarry has significant musk thistle growing. The operator should be aware of the potential for noxious weed infestation on the 1.6 acre area, and of weed control costs.

Creamtime quarry (nearby) photo: Musk thistle patches are past the sage brush.

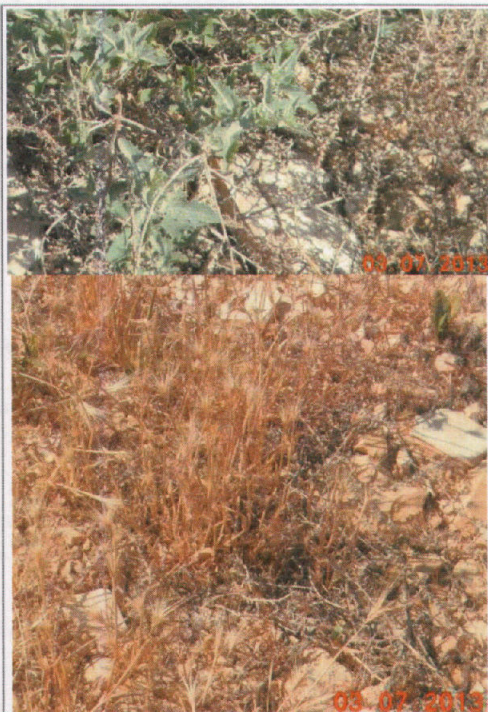
Weedy species observed in unvegetated areas. The grass was found in a few reclaimed areas.

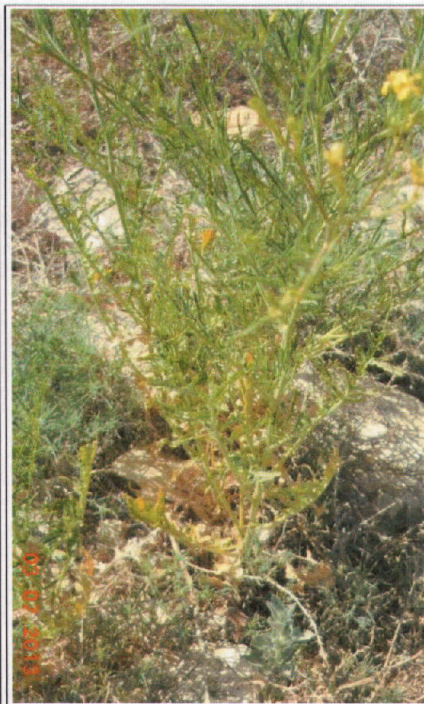
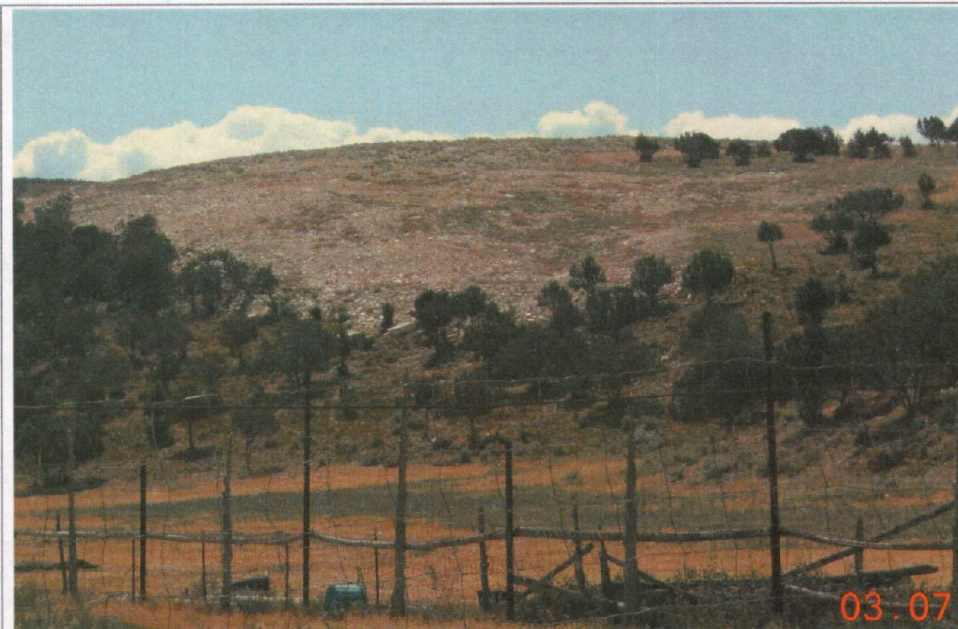
Lower end is generally not recommended for release; upper end is good. (looking southeast from road).
